Massive Challenges, Massive Successes

The Lewistown Narrows

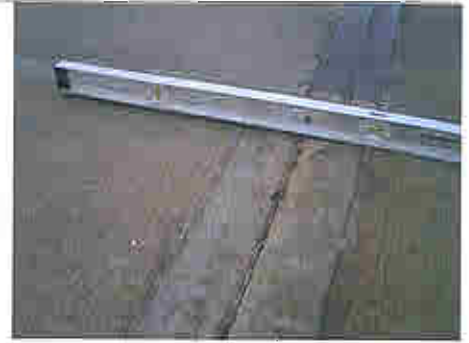
1 inch wide joint at the end of the tied arch span closed up as a result of the bridge deck system moving outward.

Based on the three-phase analysis and retrofit recommendations, the bridge rehabilitation and fatigue retrofit consisted of the removal and replacement of the bridge deck expansion joints, replacement of bearings, and replacement of the top portion of the floorbeam tie-girder connection angles. Pennoni completed the final design, while construction was handled by Cianbro Inc. The repair sequence consisted of joint repair, followed by bearing replacement. Connection angle replacement was then critical. It was important to bring the bridge deck and its elements to their original condition, releasing the accumulated stress in the deck floor system before the installation of the new connection angles. Once the expansion joints were cleaned and prepared to receive the new joints, indications of the bridge deck moving back to its original condition was observed in several locations along the bridge, even before the expansion joints were completely restored. For example, the closed bridge joint between the tied arch and the girder-floor beam system approach span was opened up to approximately $\frac{3}{4}$ " , which was 75% of its 1" design width. In addition, the stringer expansion and fixed elastomeric bearings that were deformed were observed to normalize.

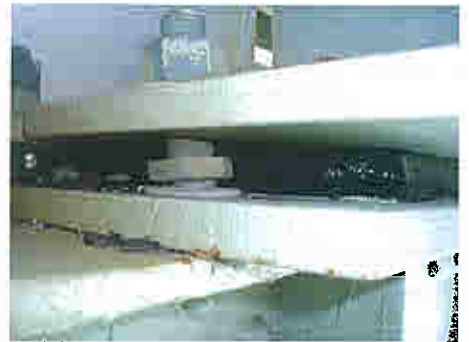
Stringer bearing and its anchor bolt being pushed towards the end of the tied arch causing extreme deformation of the elastomeric bearings and shearing of the bearing anchor bolts.
